RESTORING A SCOTT SYMPHONY

The Scott Shield-Grid Symphony

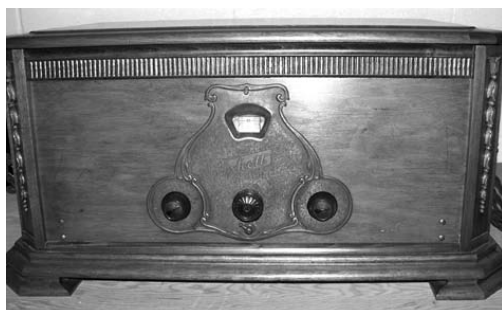
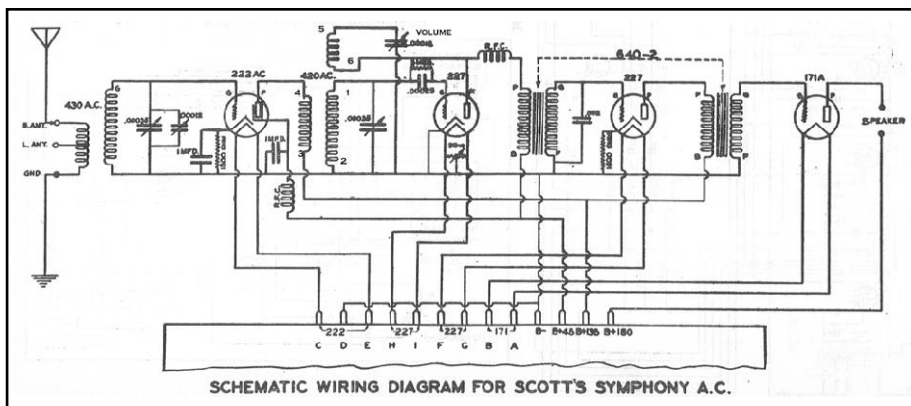
The completed Symphony was installed in a “Signal” cabinet. Testing the set on a clear, crisp evening with a relatively short, low antenna produced very acceptable results. The regeneration control acts as a volume control (right knob). The trimmer on the left is connected in parallel to the main tuning control and is used for fine tuning. Because no owner’s manual has ever been found for a Symphony, we do not know how Scott referred to this control.

The result: a rare and handsome piece ready to take its place in the author’s collection.
